**O & M INSPECTION REPORT
FOR NAVIGATION AND SHORE PROTECTION PROJECTS**

1. Project Name: Auasi SBH
2. Date of Inspection: April 6, 2004
3. Inspection Personnel:

As a result of the FY04 Continuing Eligibility Inspection conducted on April 6, 2004 the project was rated **SATISFACTORY**, Project Condition Code is **ACCEPTABLE** and the project is considered **ACTIVE** in the Rehabilitation and Inspection Program.

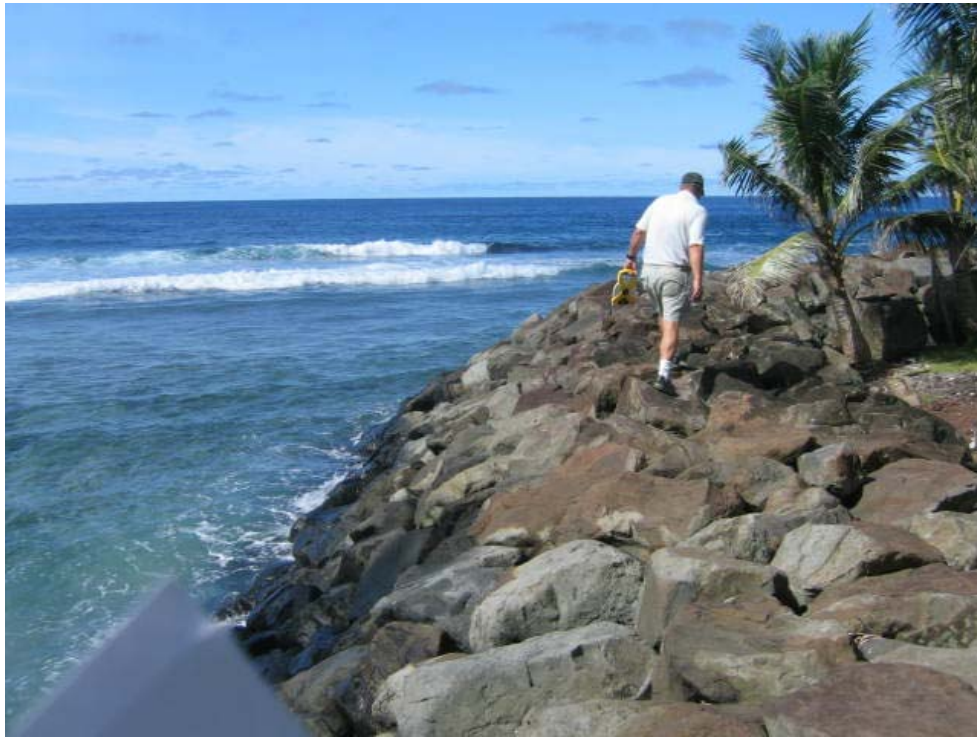
a. Approximate Sta. 0+25, No damage to Revetment Reach 1.

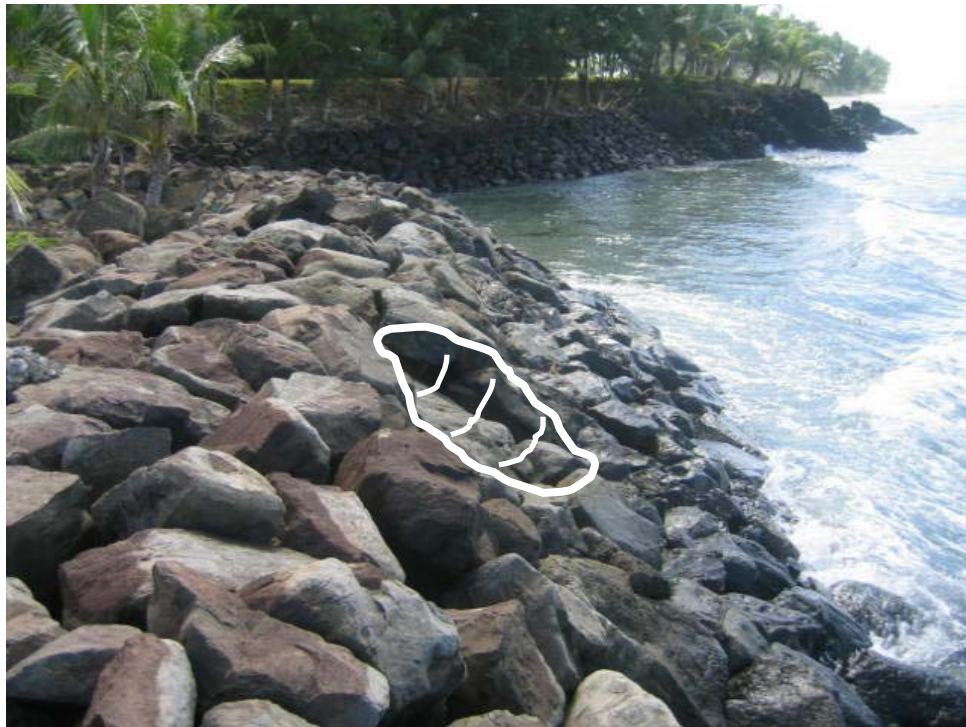
c. Sta. 1+11, OS, Settling at side slope hinge, approx. 5 ft diameter.

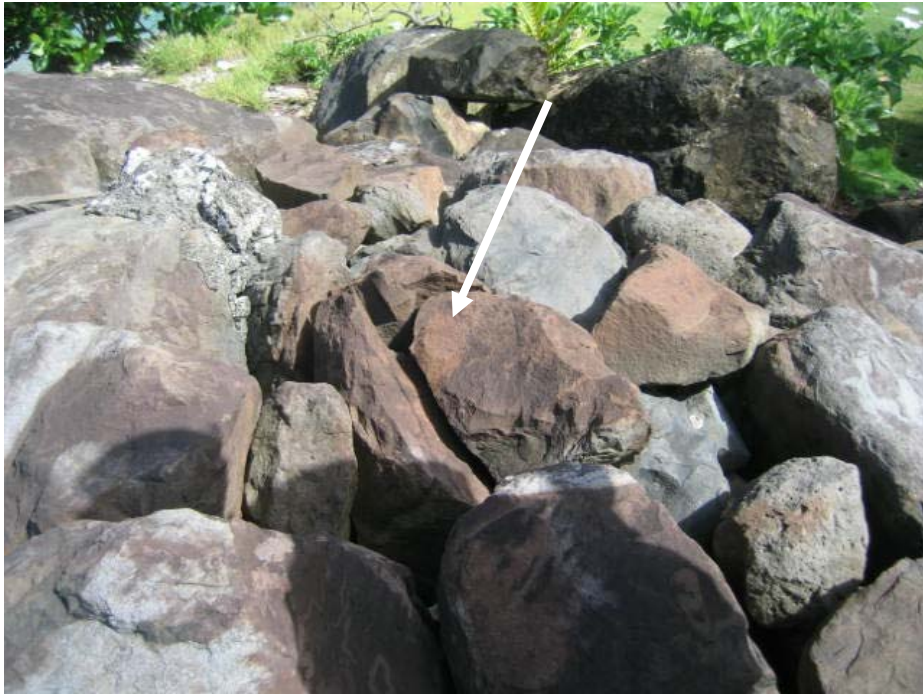
c. Sta. 1+27, fractured stone on crest.

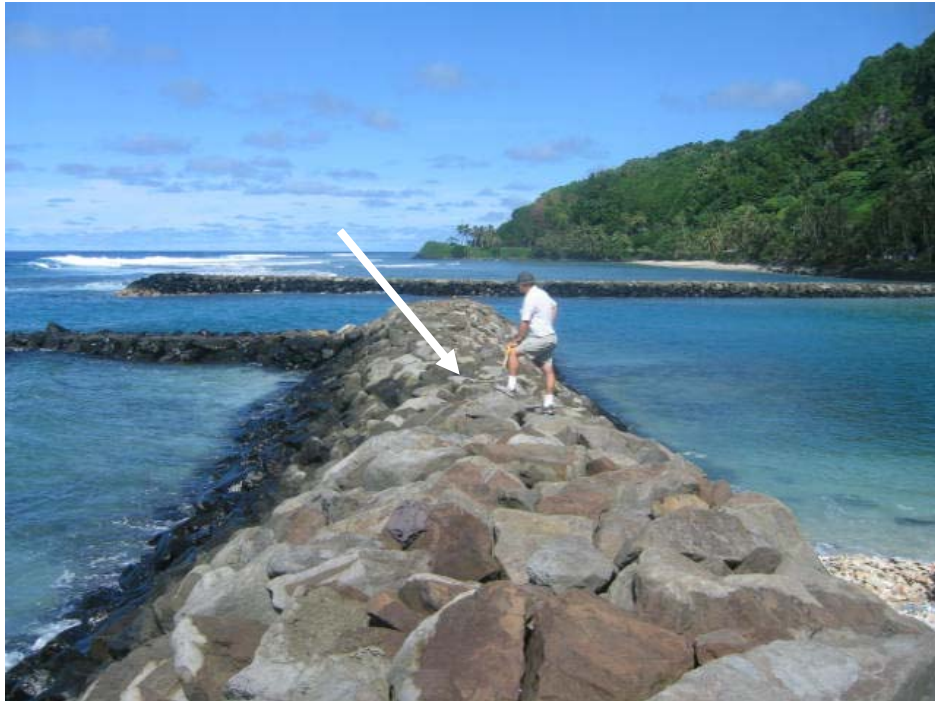
d. Sta. 1+65, End of revetment and crest elevation change, single perched stone on centerline.

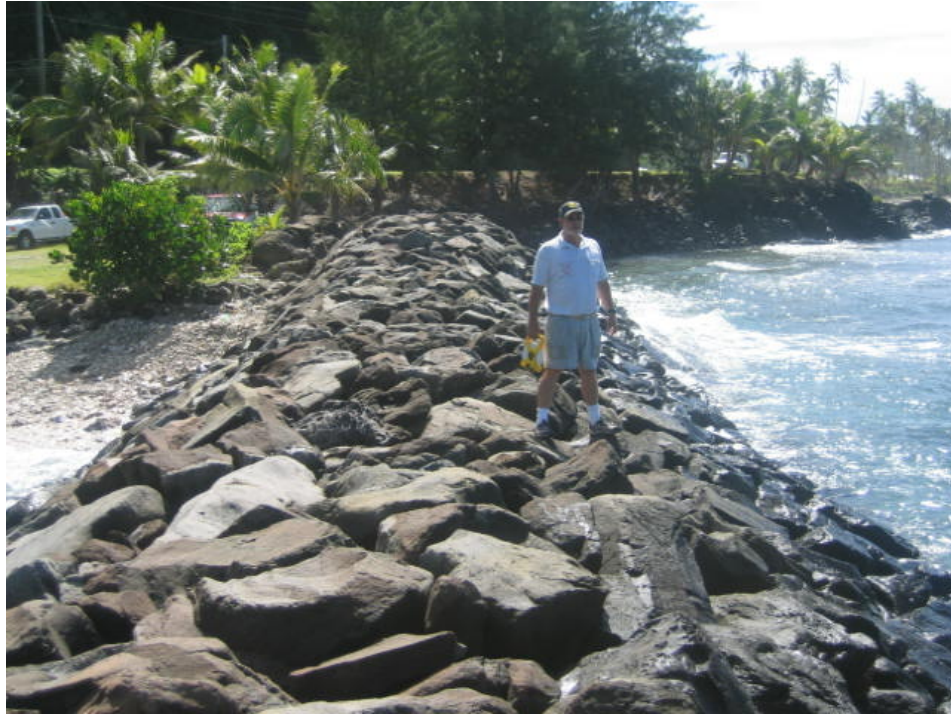
e. Sta 2+30, OS, Minor settling of crest and hinge.

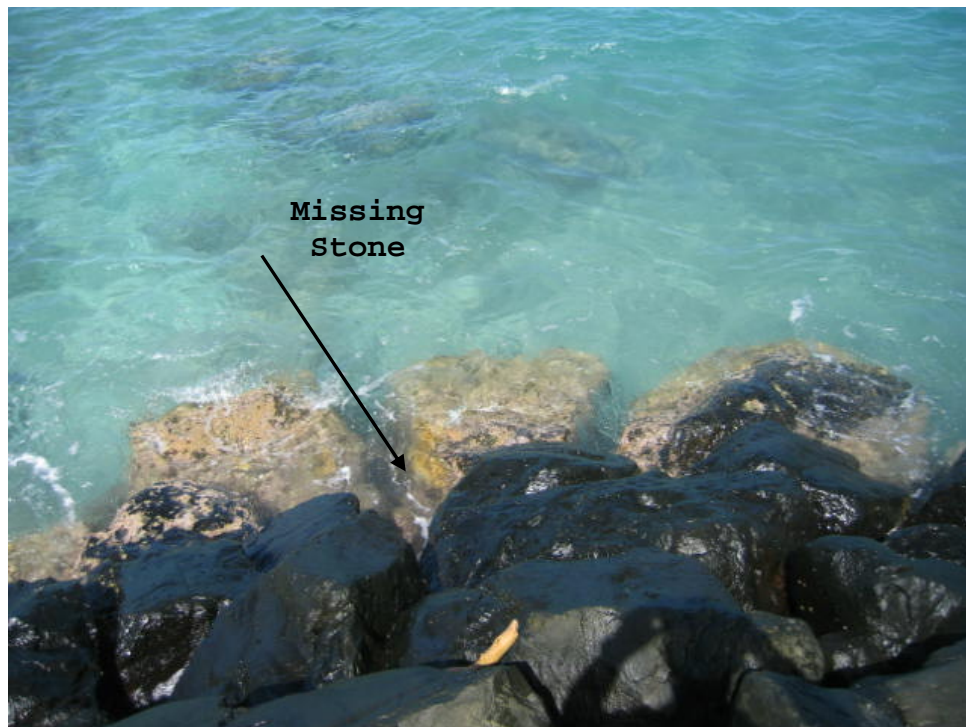
e. Sta 2+87, End of breakwater, toe stones intact, possible missing stone.

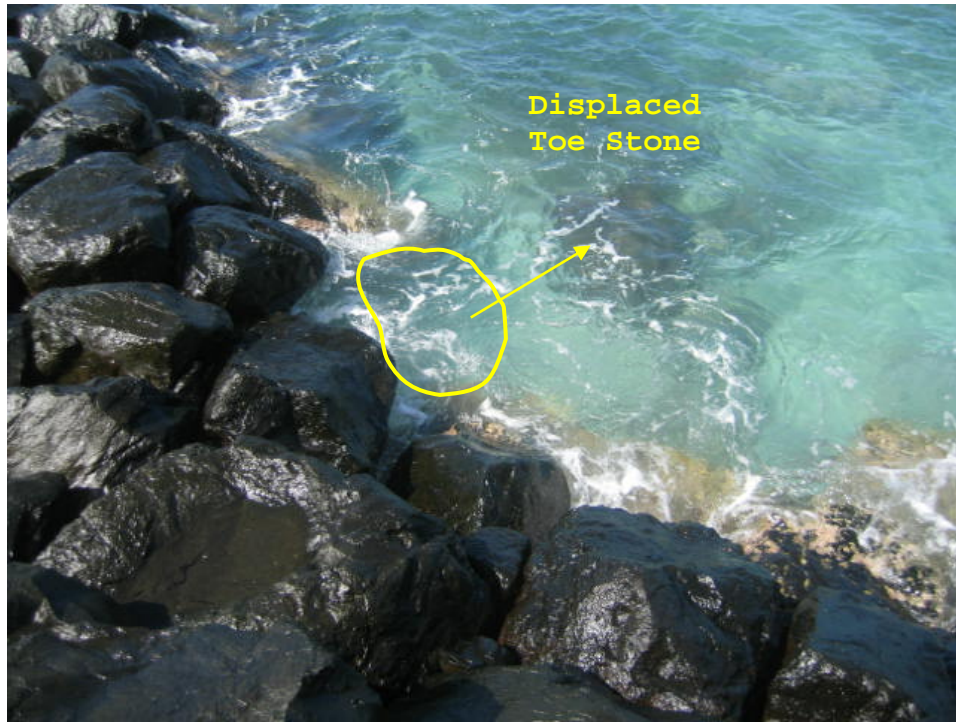
f. Sta 0+00 (Jetty), HS, Toe stone displaced at breakwater/jetty joint.

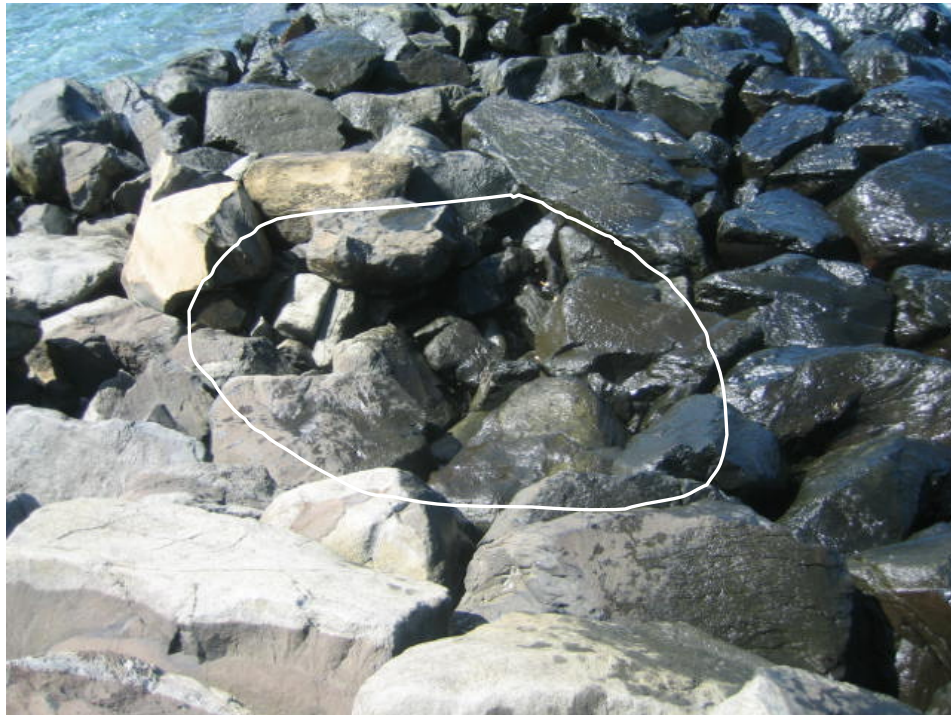
g. Sta. 0+05 (Jetty), Crest, Monitor dislodged armor stones, underlayer exposed. (same as previous year, 2003)

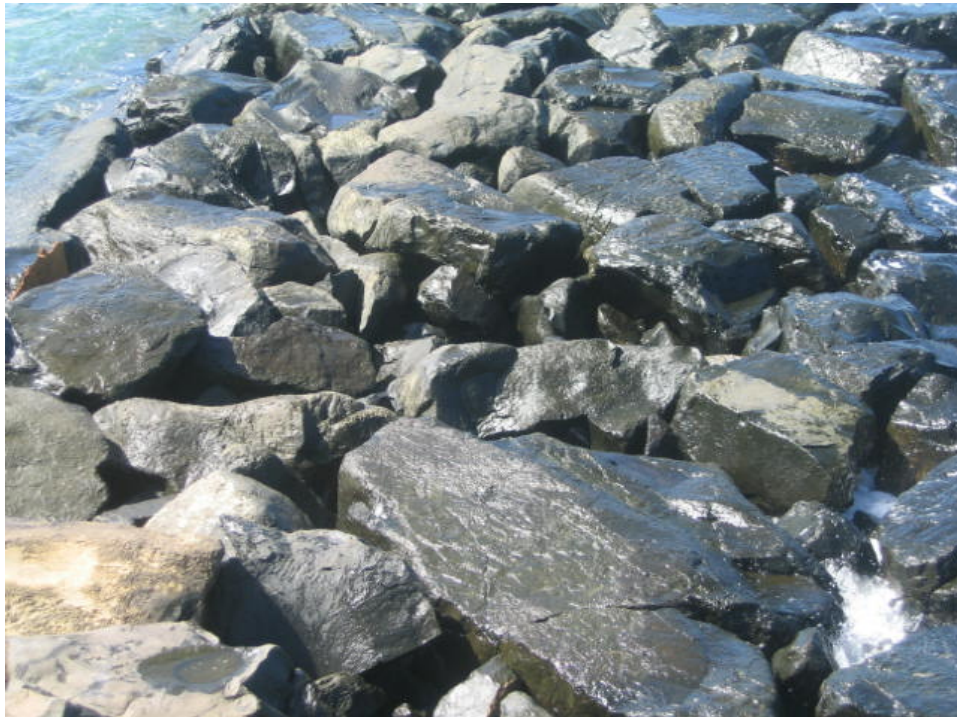
h. Sta. 0+17 (Jetty), Crest missing armor stone with underlayer exposed.

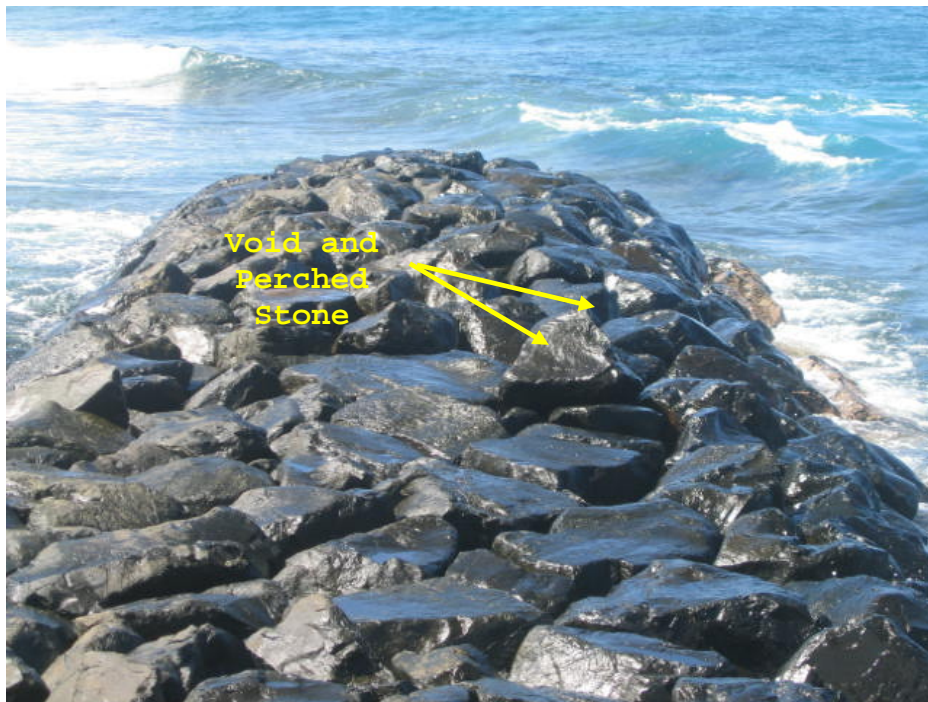
i. Sta. 0+48 (Jetty), Crest/HS, perched armor stone resting on crest and void.

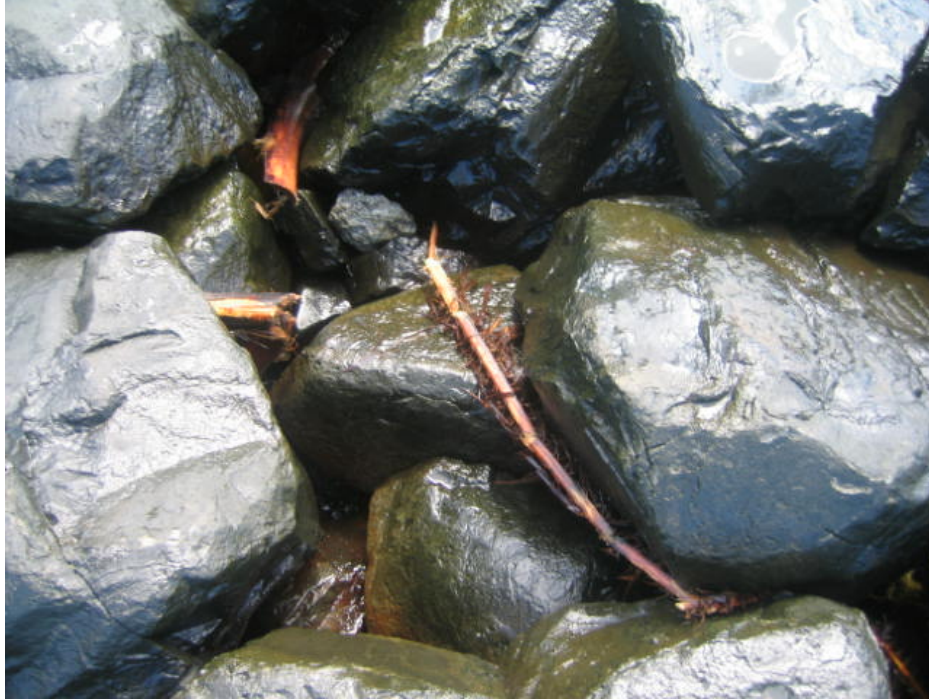
j. Sta 0+48 (Jetty), OS, Tipped stone and void.

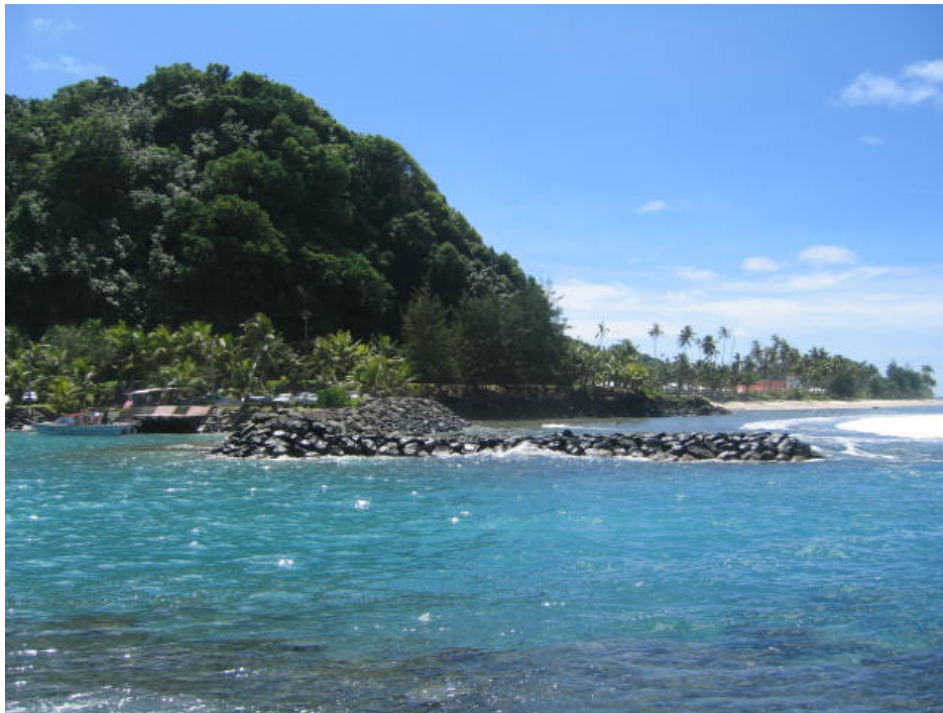
k. Sta 0+90 (Jetty), End of jetty, head is in good condition.

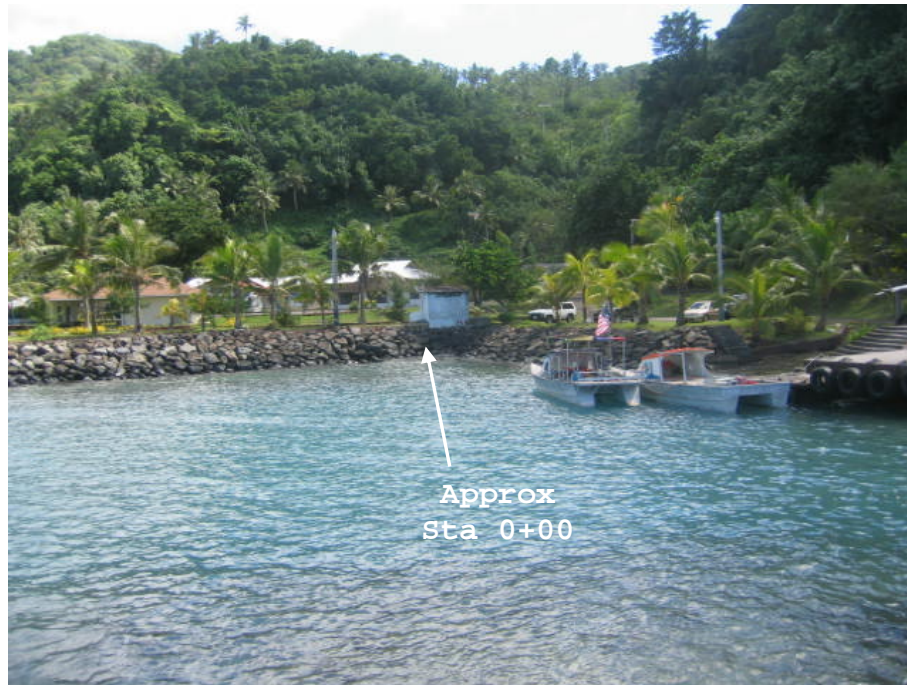
Notes: Sta 0+00 marked by metal pole.
Sta 0+35, small coconut tree growing.

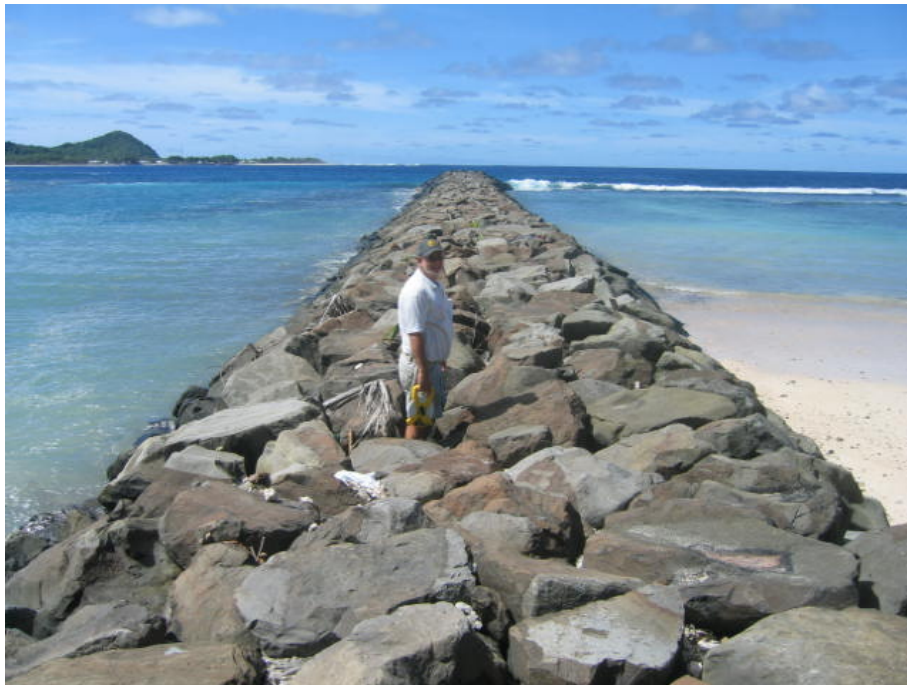
a. Sta. 0+55, Crest, void at centerline (2'x 2'x 2').

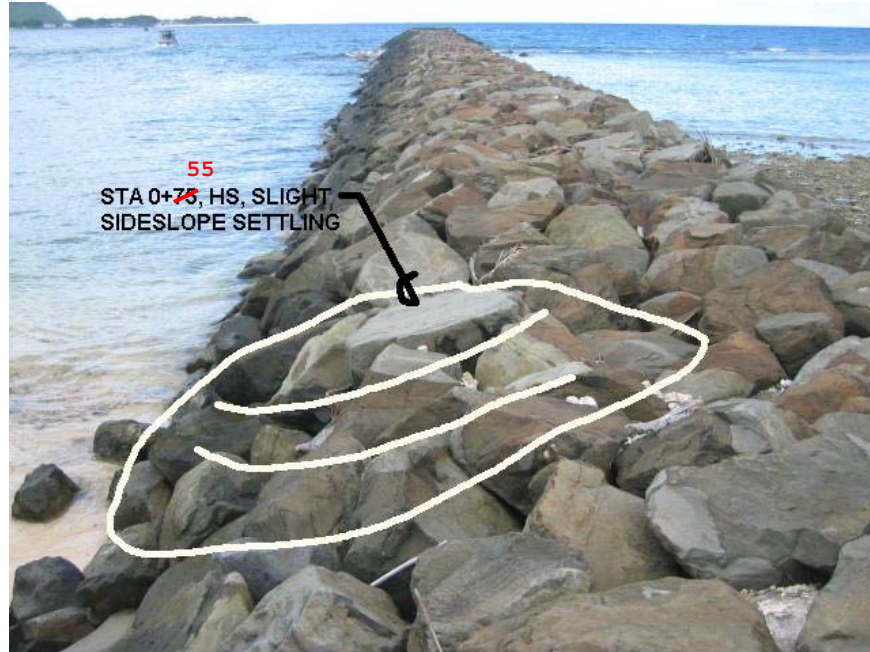
b. Sta. 0+55, HS, slight sideslope settling, 10'x5' area. (2003 Photo)

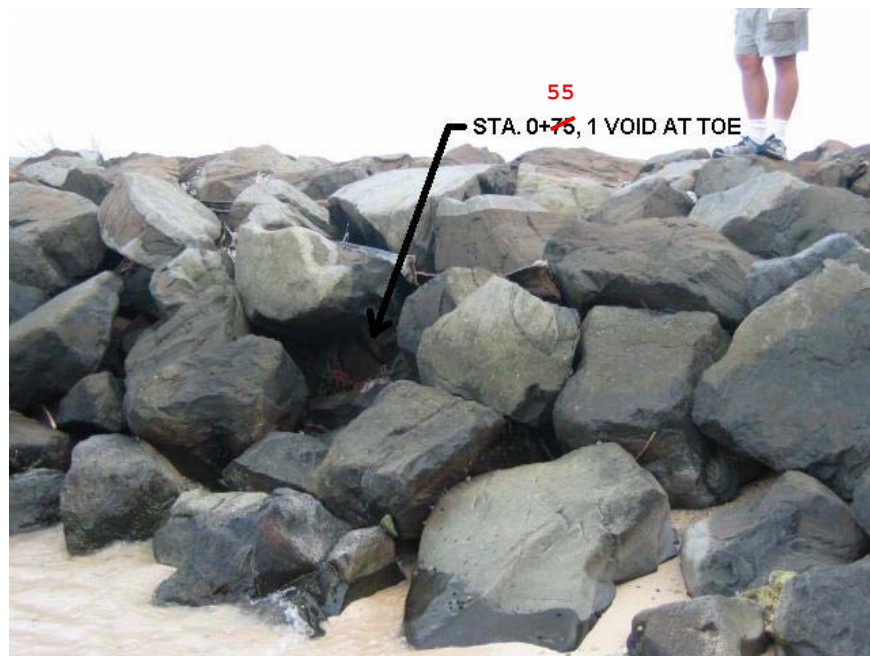
c. Sta. 0+55, HS, void at toe. (2003 Photo)

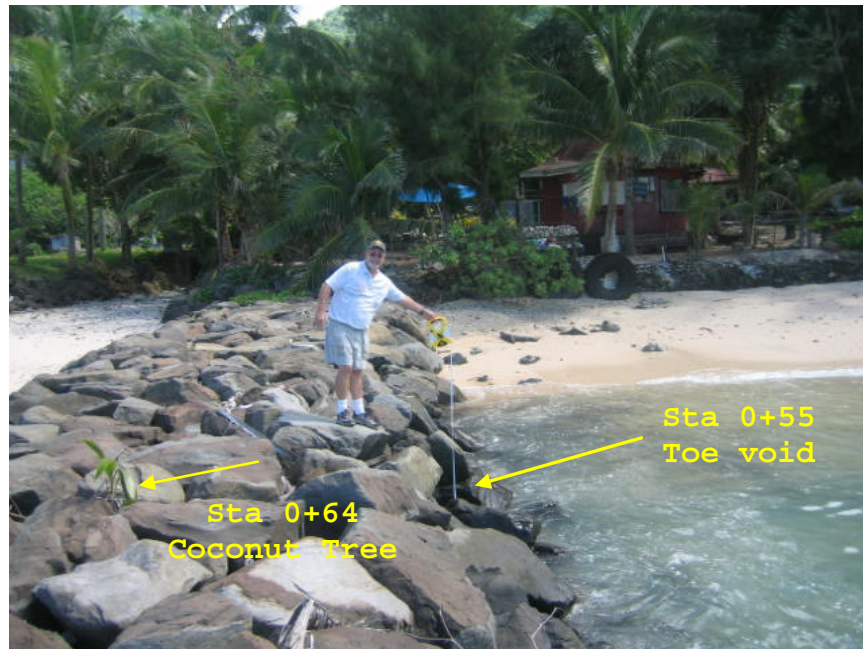
d. Sta 0+64, CL, Coconut tree growing.

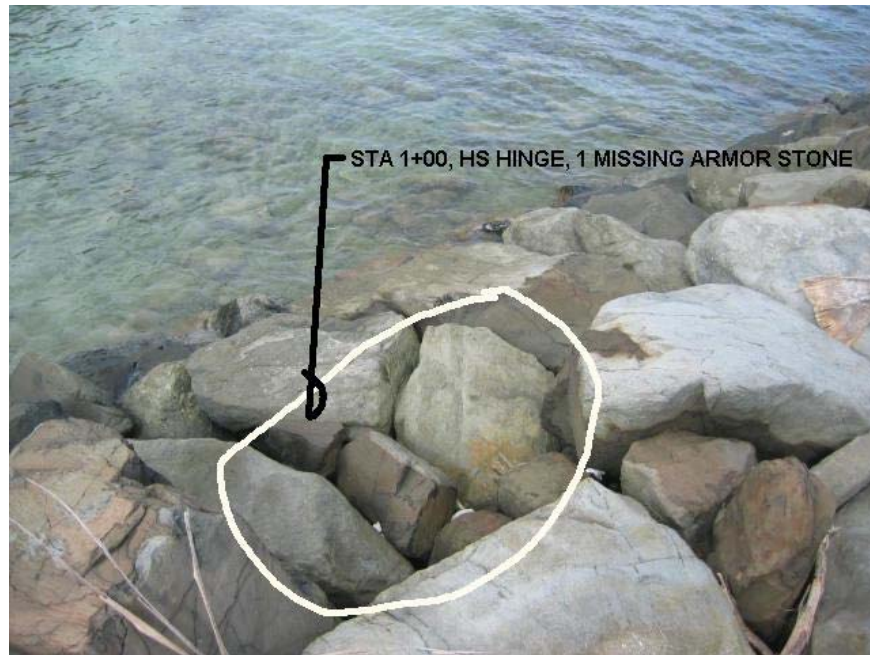
d. Sta. 1+08, HS, 1-ea missing armor stone at hinge. (2003 Photo)
Note: Coconut trees at Sta 0+99 and 1+13.

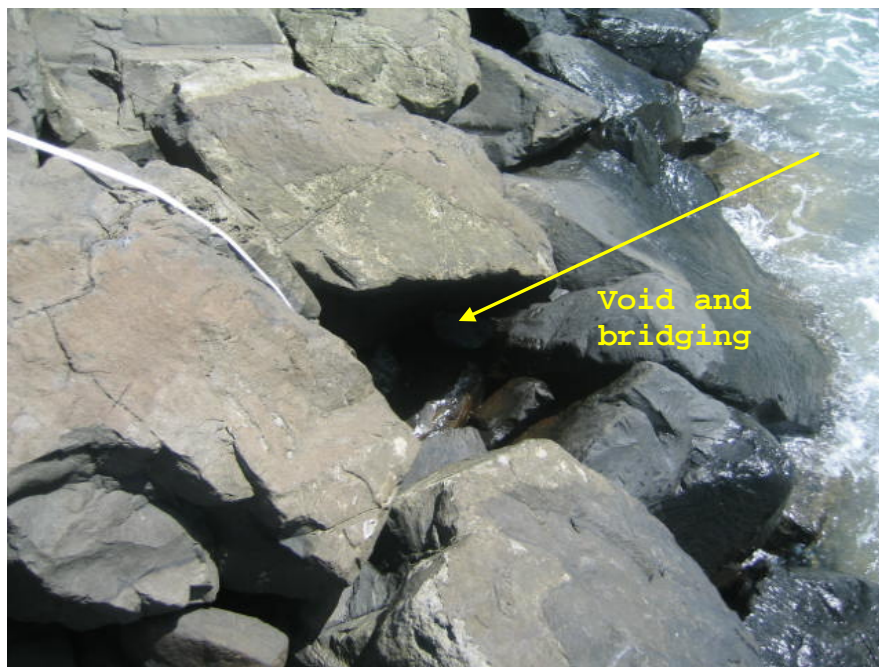
e. Sta 1+84, HS, Small void at CL of crest with underlayer exposed(not shown), void halfway down HS sideslope, one stone bridging.

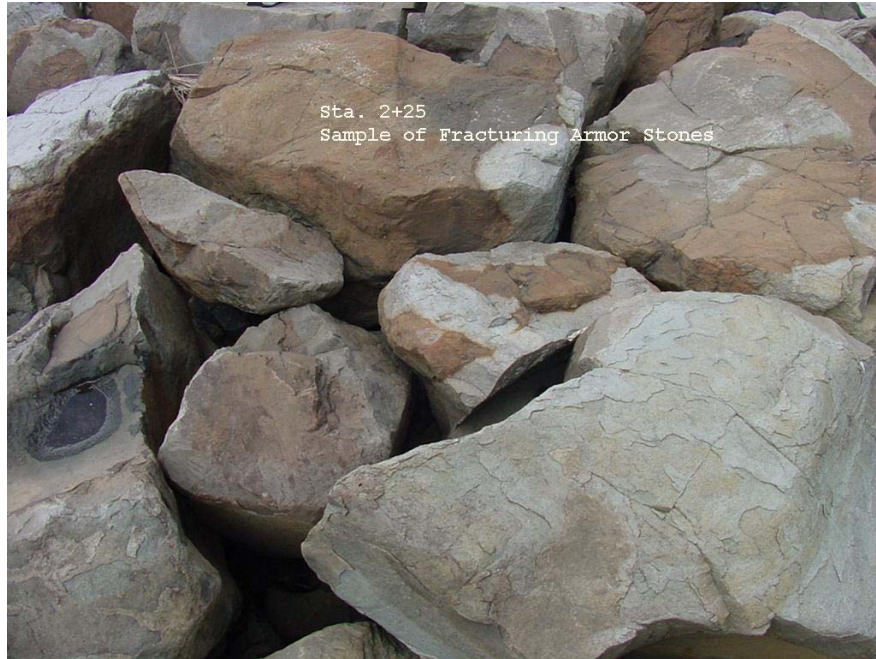
f. Sta. 2+25, crest, 2 split armor stone, split due to overblasting at the quarry site during quarrying operation (2002 PHOTO).

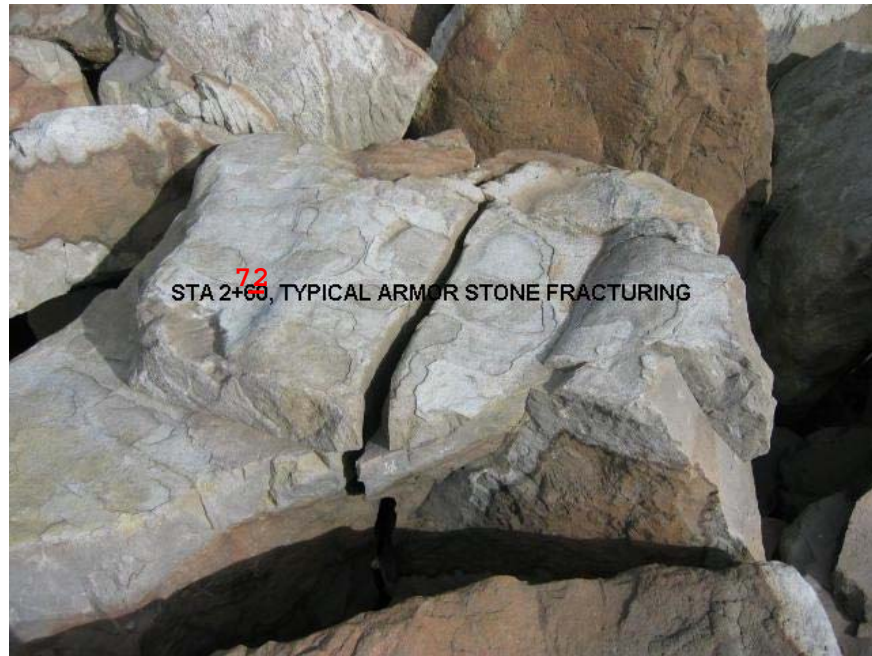
g. Sta. 2+72, HS, 1 split armor stone.

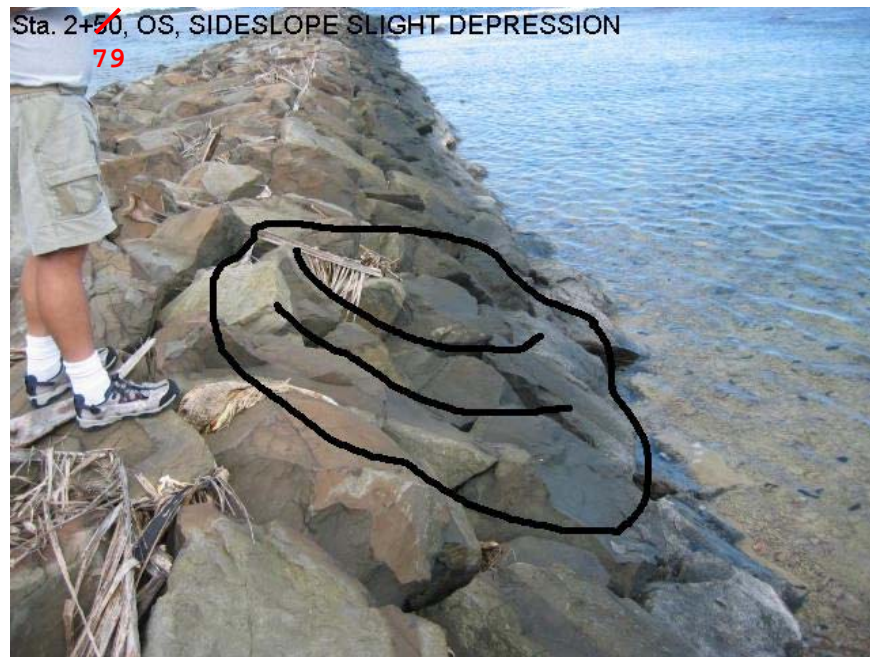
h. Sta. 2+79, OS sideslope slight depression.

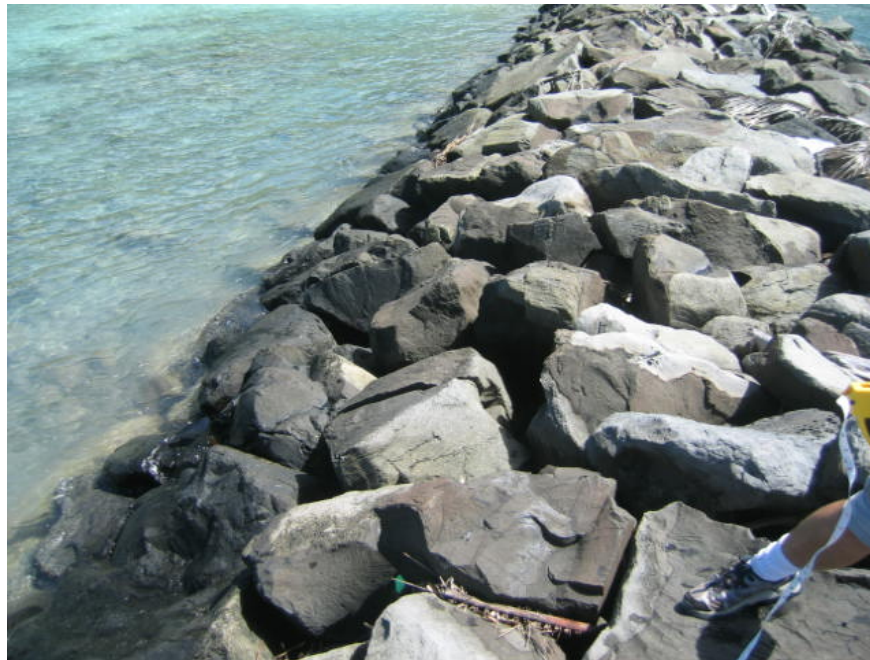
i. Sta 3+12, HS, Sideslope and hinge settling, UL exposed.

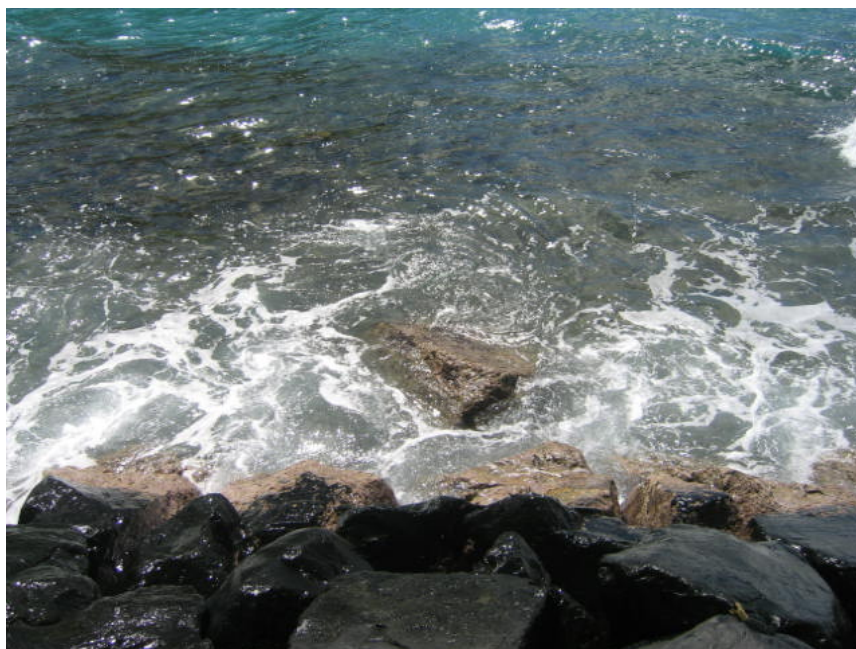
j. Sta. 3+52, HS, 1 dislodged armor stone at the toe.

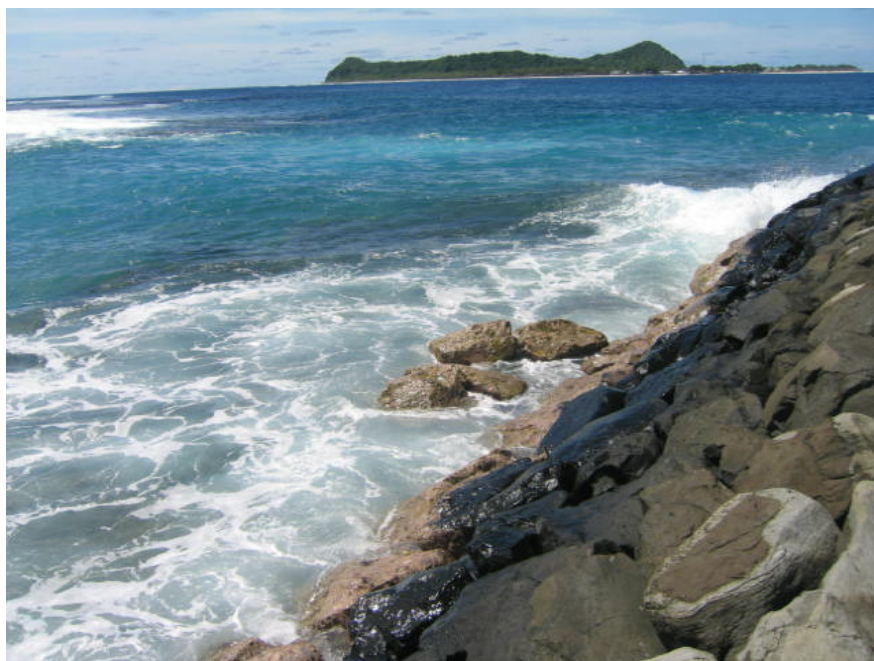
k. Sta. 3+87, HS, 4 armor stones resting 3' from the toe of the structure, no obvious voids.

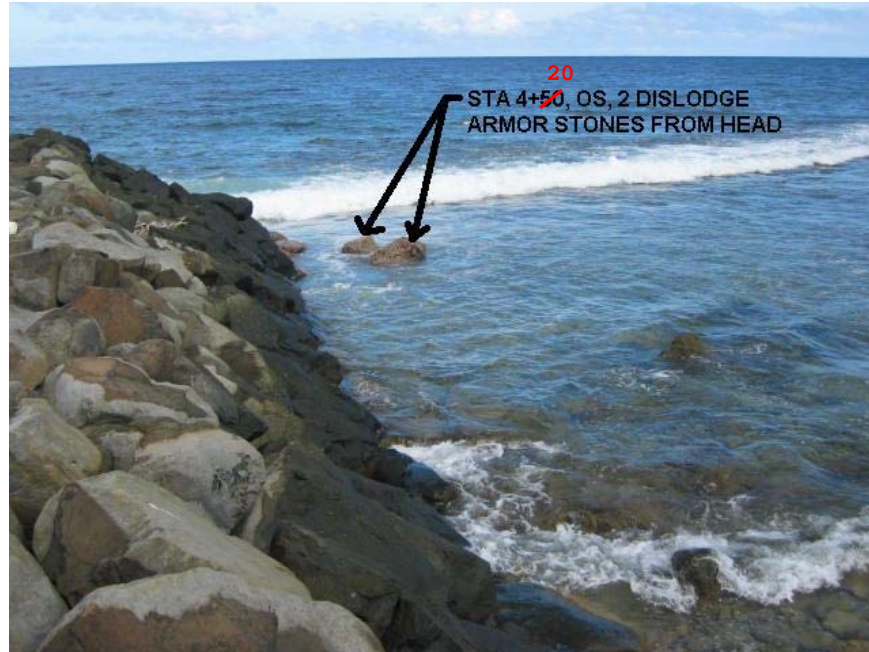
1. Sta. 4+20, OS, 2 dislodged armor stones from head.

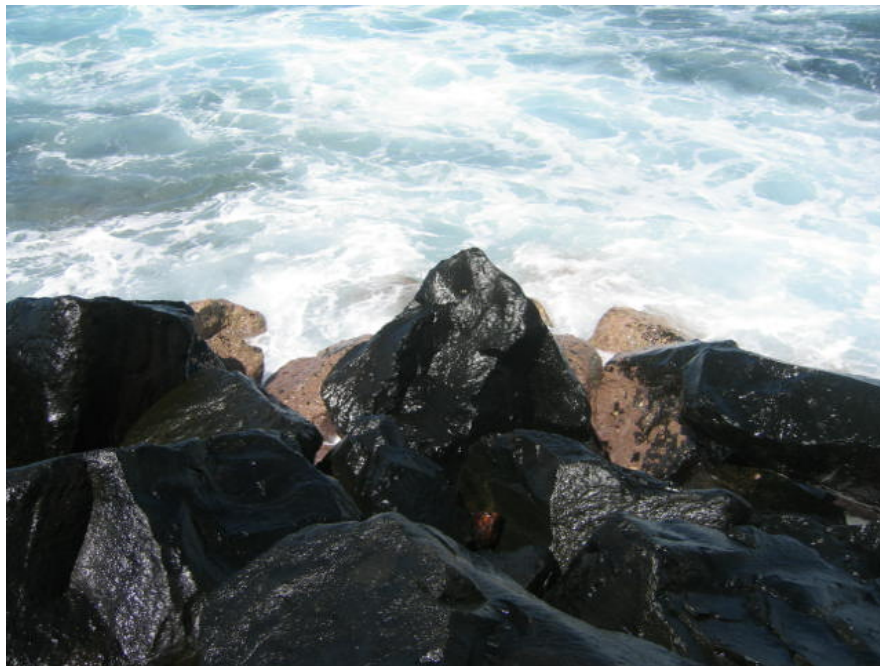
m. Sta 4+30, Head, Voids and sideslope failures on OS (crest to water level, 0-80 degrees).
